2010 Outstanding Repair & Rehabilitation Project

Concrete Arch Bridge No. 6.45 over 31st Street, Queens, NY

By Tommy Pirkle and Arden "Morris" Boddie

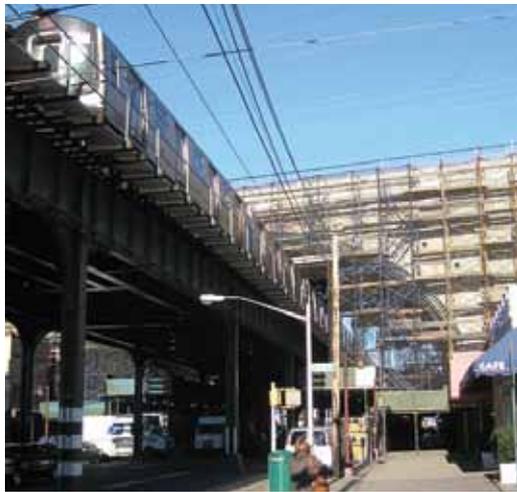
As a safety precaution, stage scaffolds and netting were erected long before the work started to protect the subway tracks and, more importantly, the pedestrians on the station platforms and sidewalks below

Amtrak had little choice but to rehabilitate this 94-year-old structure, as falling chunks of deteriorated concrete were becoming a major structural and safety concern. As a safety precaution, stage scaffolds and netting were erected long before the work started to protect the subway tracks and, more importantly, the pedestrians on the station platforms and sidewalks below.

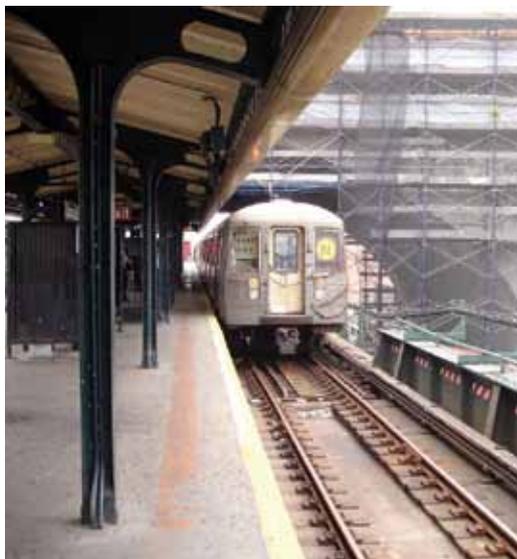
The Ditmars Boulevard Subway Station is partially inside the arched bridge

The Astoria Line is a rapid transit line of the BMT division of the New York City Subway. This is an elevated structure that runs directly above 31st Street and through the 220 ft (68 m) long by 80 ft (24 m) high arch that spans the street. The Ditmars Boulevard Subway Station is partially inside the arch and is serviced by the N and W trains.

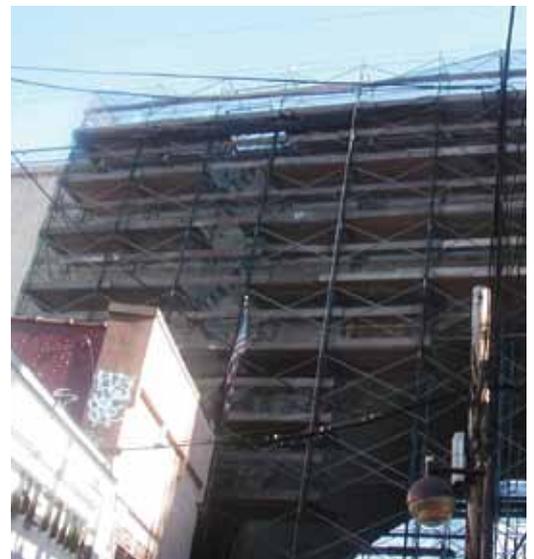
Scaffolds were erected over the elevated subway tracks and 31st Street

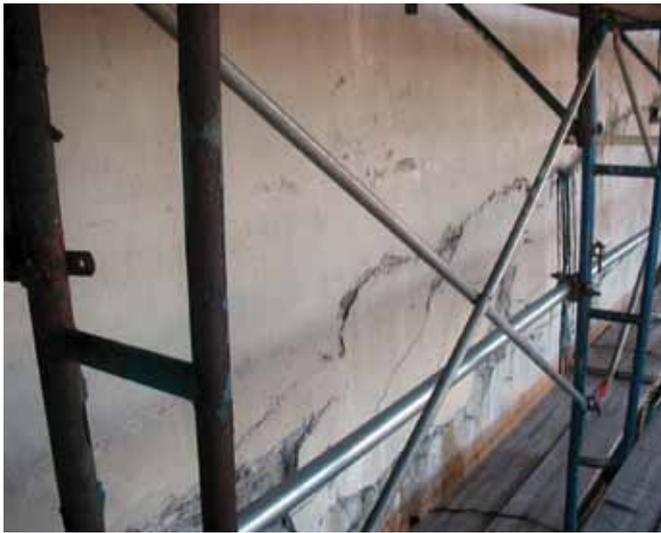
Typical minor concrete spalling

The General Contractor, ECI Building Corp of Elmont, NY, performed most of the surface preparation, starting with the north side of the structure. The substrate was sounded and marked and any deteriorated concrete was removed with pneumatic chipping hammers. Many repairs exceeded 12 in. (300 mm) in depth with continuous infiltration of groundwater. Weep pipes were installed to relieve the water pressure and a highly accelerated dry-mix shotcrete material was locally applied to divert the water to a central downward flow. The substrate was then hydroblasted to remove all existing coatings, contamination, and graffiti and “roughen” the surface to a minimum of 0.25 in. (6 mm) amplitude. L-shaped No. 3 dowels were installed 36 in. (900 mm) on center (OC) and coated 4 x 4 in. (100 x 100 mm) x D2.9 x D2.9 welded-wire reinforcement was attached to the dowels.

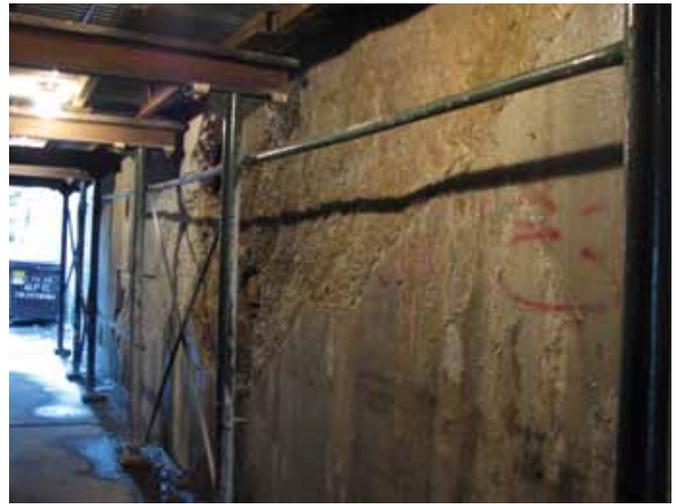
Typical severe concrete spalling with continuous groundwater infiltration

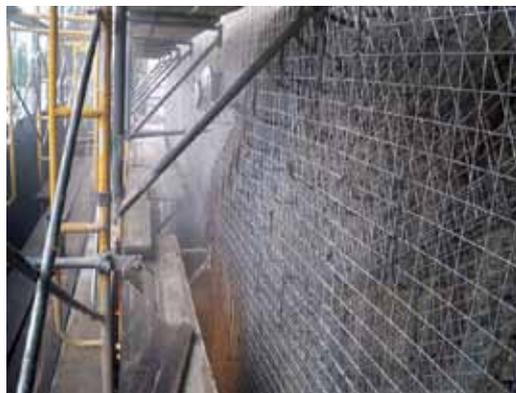
Double and triple mats of 4 x 4 in. (100 x 100 mm) welded-wire reinforcement installed in severely deteriorated locations

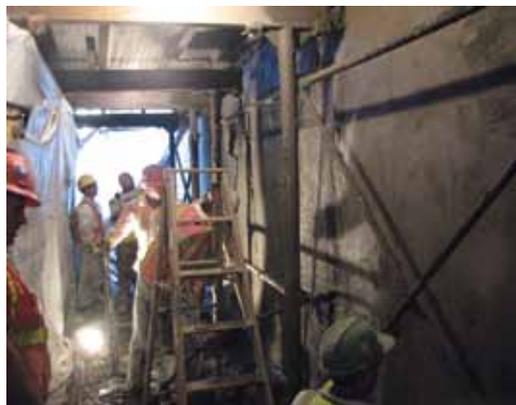
Wet-mix shotcrete was the only acceptable method the engineer would entertain to minimize and control the dust and rebound

The specifications required a minimum 4000 psi (27.5 MPa) prepackaged, fiber-reinforced shotcrete material. The engineer specified wet-mix shotcrete as the only acceptable method

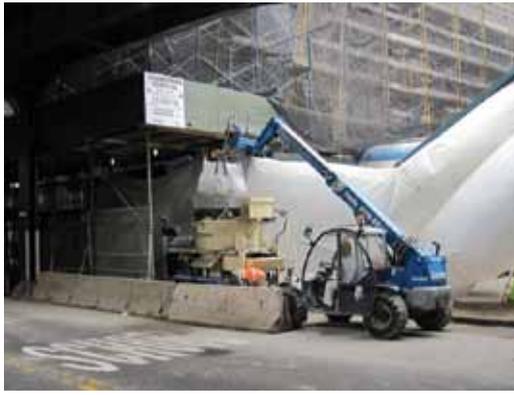
A self-contained machine was selected—one that far exceeded the necessary requirements for mixing volume and pumping distance and was capable of mixing bulk bags

With the material submitted and approved, the next decision was to determine the type of equipment to use. Transit trucks for mixing were considered, but a mixer/pump combination machine was preferred because it would allow for total control of the mixture. A self-contained machine called MR-IT by Allentown Shotcrete Technologies was selected—a durable and reliable self-contained mixer-pump combination that was capable of mixing the full contents of the 1100 lb (500 kg) bulk bags in one batch and exceeded the necessary requirements for pumping distance. An off-site test was conducted with the pump for material compatibility and training of company personnel to properly operate and maintain the pump.

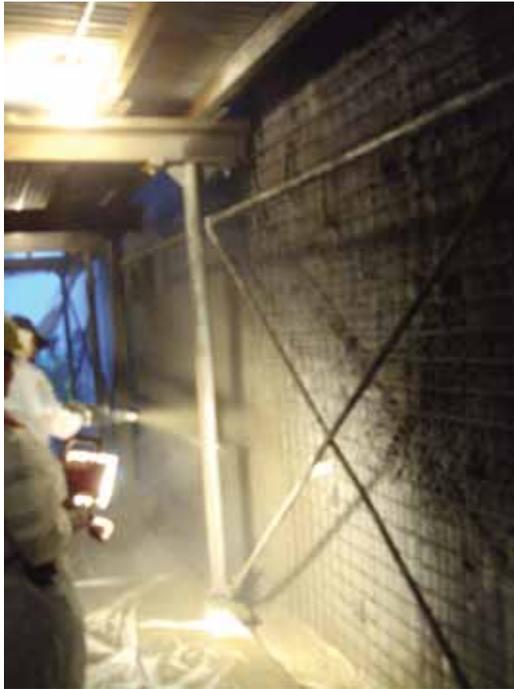
Prepackaged fiber-reinforced wet-mix shotcrete was applied

Because of the complex nature of the job, a daily conservative production rate was estimated. On August 5, 2009, the first day of shotcrete application, fourteen 1100 lb (500 kg) bags were applied to complete 450 ft² (42 m²). Production greatly increased each day; the most productive day was September 3, when sixty-four 1100 lb (500 kg) bags were applied to complete 1650 ft² (153 m²). It took 18 shifts to complete the total area of 15,560 ft² (1446 m²). This included filling in the spalled areas with another 25 yd³ (19 m³) of material.

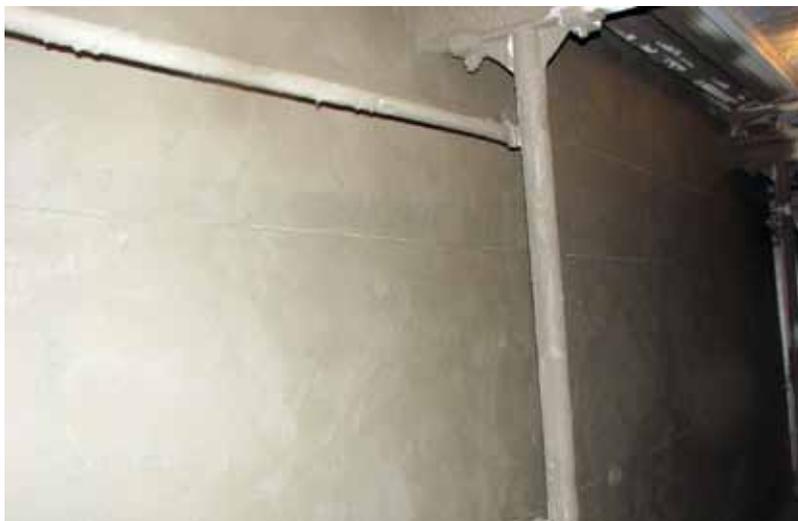
The uniformed float finish provided an excellent textured surface for the coating adhesion

An often overlooked but significant factor in providing a long-life facility is preparing the structure for preventive maintenance. The uniformed float-finished shotcrete provided an excellent textured surface for the adhesion of the coating for protection against the elements.

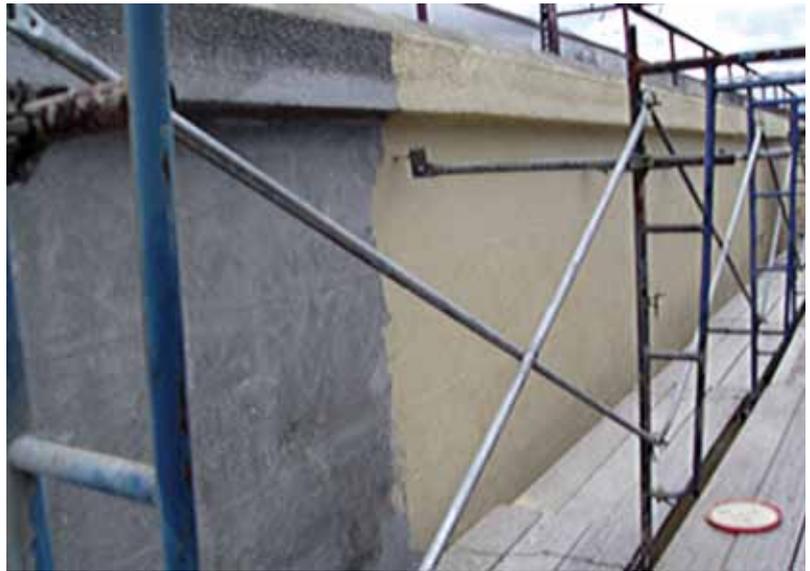
Two coats of a water-dispersed, acrylic, anti-carbonation coating were applied

Twenty-eight days after placement of the shotcrete, the structure was lightly pressure washed and two coats of a bone-colored, water-dispersed, acrylic, anti-carbonation coating were applied with rollers.

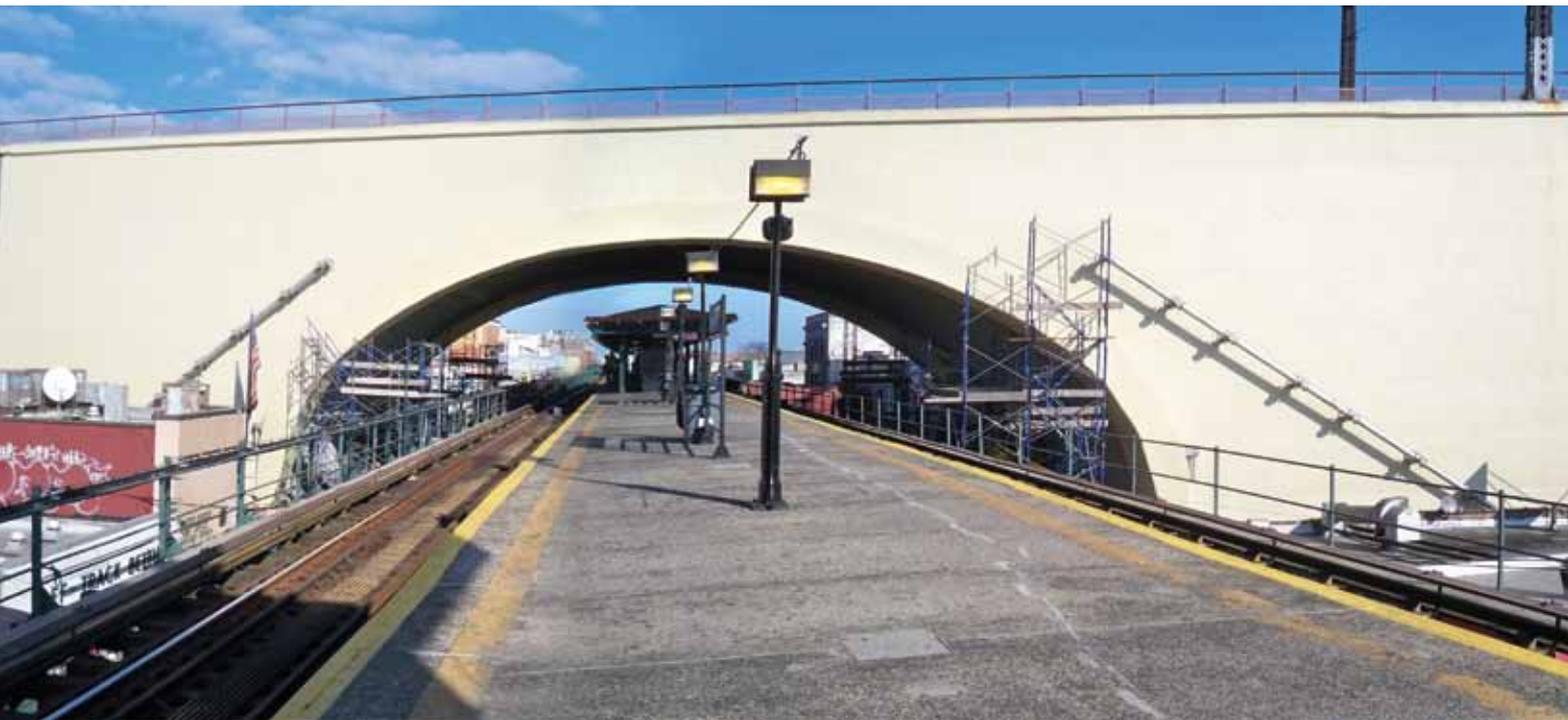
View of completed project from Ditmars Boulevard Subway Station
